3 Design and Develop Fast Scan Infrared
Detection and Measuring Instrument, 2#

REPORT ON PHASE IV: 2#

EXPERIMENTAL STUDY 6

1 Raytheon Company

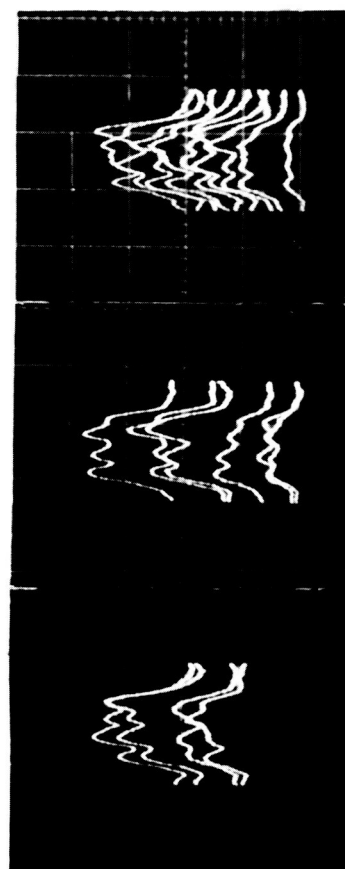
Figure 25. Scanning-Speed Test of Line D-180

In scanning the above transistors, it was found that when the emitter was viewed, the traces showed 2 waveforms that alternated during warmup (see Figure 25d). It should be kept in mind that the pulses coming from the Tektronix Curve Tracer are occurring at a rate of 120 cps, while the scan traces are taken at 1-second intervals, for a duration of 10 milliseconds each.

Every other trace is photographed in Figures 25a and 25b, whereas 25d and 25e are every trace. Figure 25c shows lines 1, 2, 5, 6, 9, and 10--the alternating phenomenon spread out by eliminating some of the intermediate traces 3, 4, 7, and 8. The scanning speed was then slowed down, and similar pictures were taken. Figures 25a' and 25b' show every other scan, and 25c' shows every scan. This symmetry could be a phasing relationship of the pulsing of the transistor by the Curve Tracer to the scan speed of the polygon. The speed at which these curves are varying is indicative of the speed of the SB process and should allow a better understanding of this phenomenon.
